Crashworthiness of Small Poststandard School Buses: Safety Study

U.S. National Transportation Safety Board
Washington, DC

October 11, 1989

NTSB Number SS-89/02

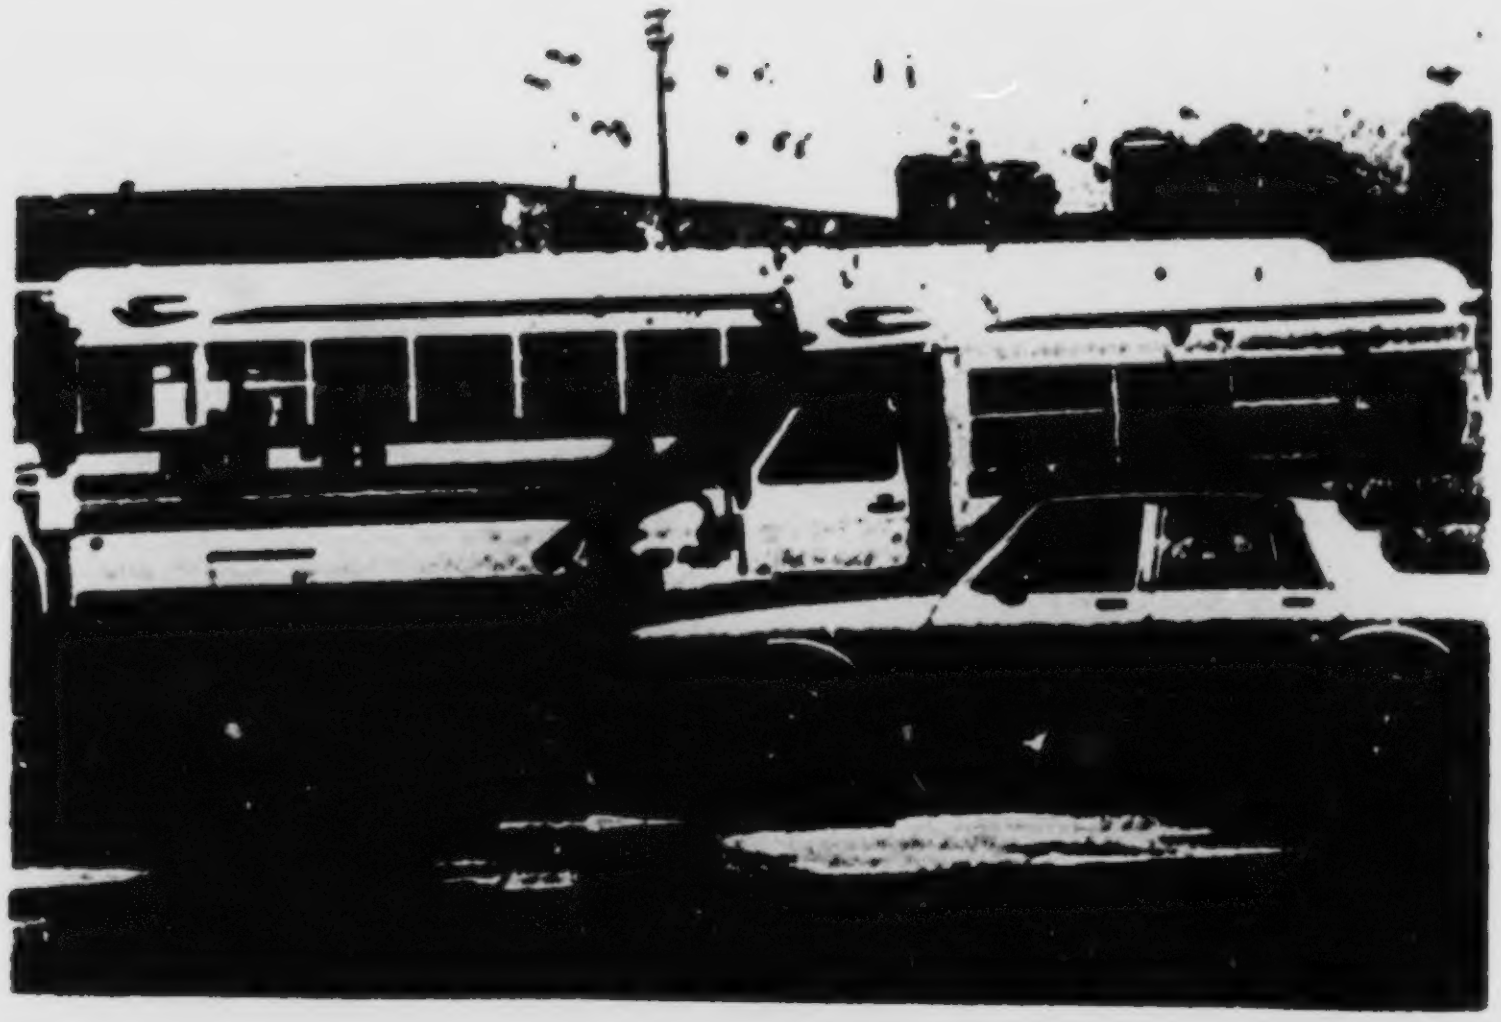
Figure 2.--A small school bus is closer in size and weight to a passenger car than to a large school bus. In this photo, a 66-passenger school bus and a 22-passenger school bus are parked alongside a Chevrolet Caprice. If a school bus is involved in a collision with a car, the crash forces experienced by passengers riding on the small school bus will be much more severe than if they had been riding on the large school bus.

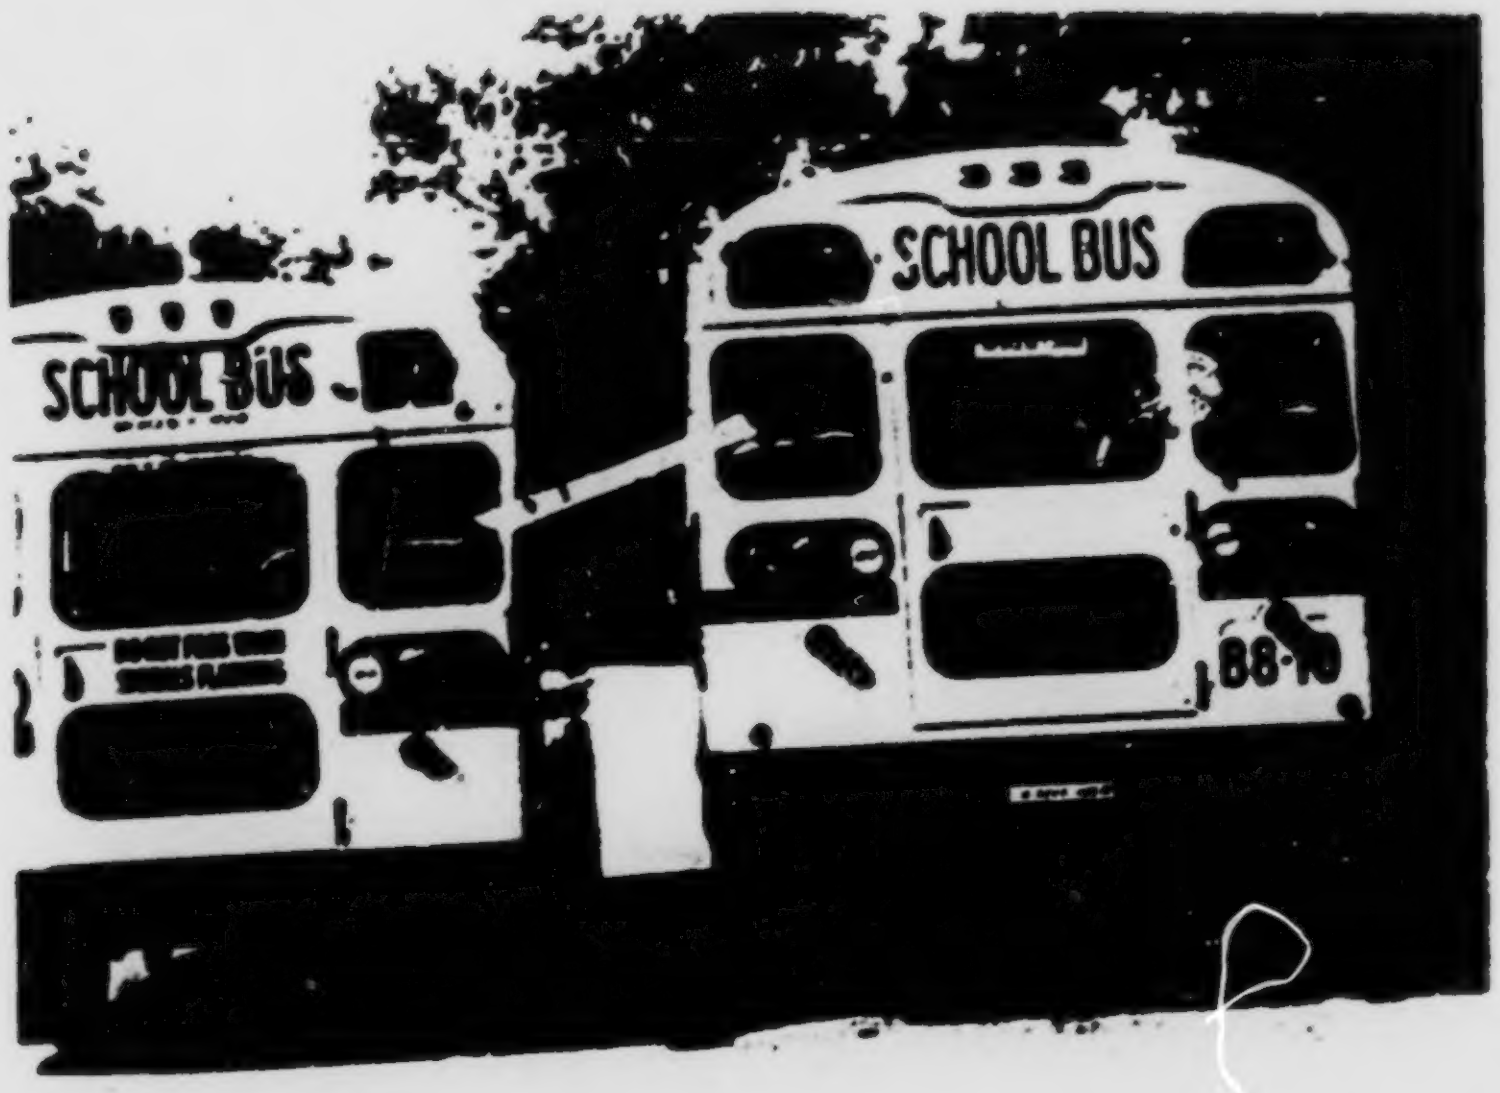
Figure 3.--Passengers seated in a small school bus are closer to the ground, and closer to the level at which a passenger car would impact, than passengers seated in a large school bus. (A school van is pictured at left; a large school bus is at right. The difference in heights of seatbacks from road level is indicated.)

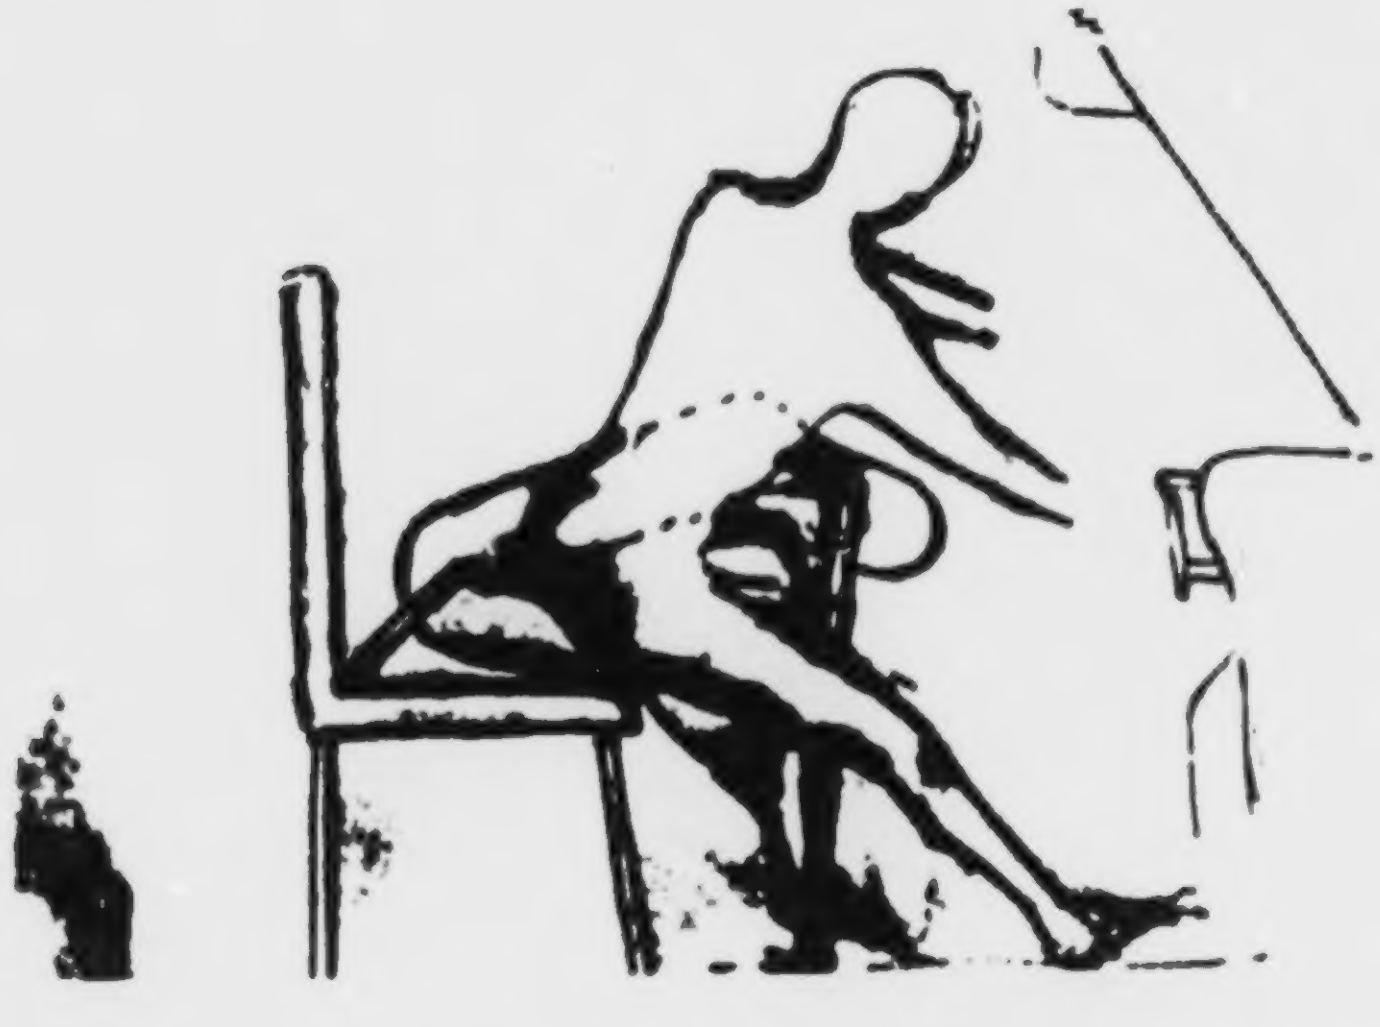
Figure 8.--Artist's sketch of body movements of the two fatally injured passengers in case 17 at the moment of initial impact.

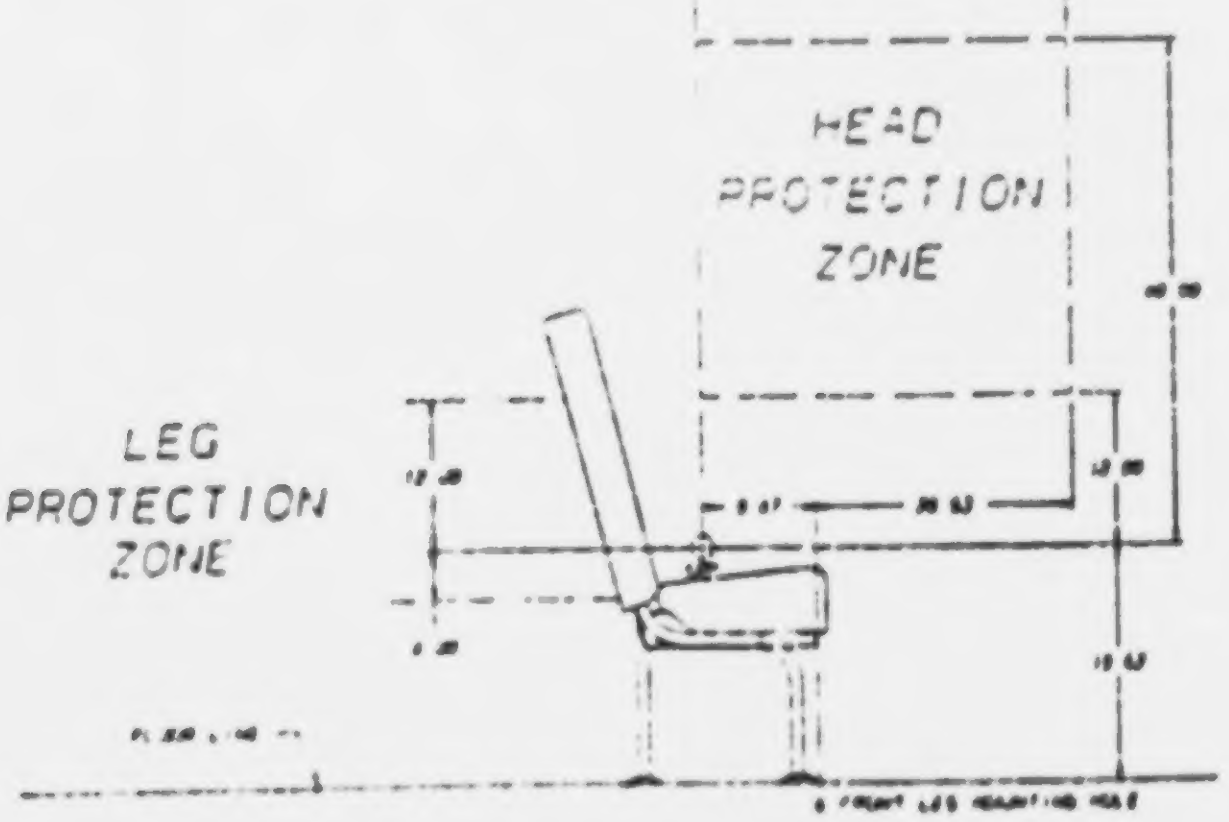
Figure 12.-- The dimensions of the head and leg protection zones apply to all sizes of school buses.

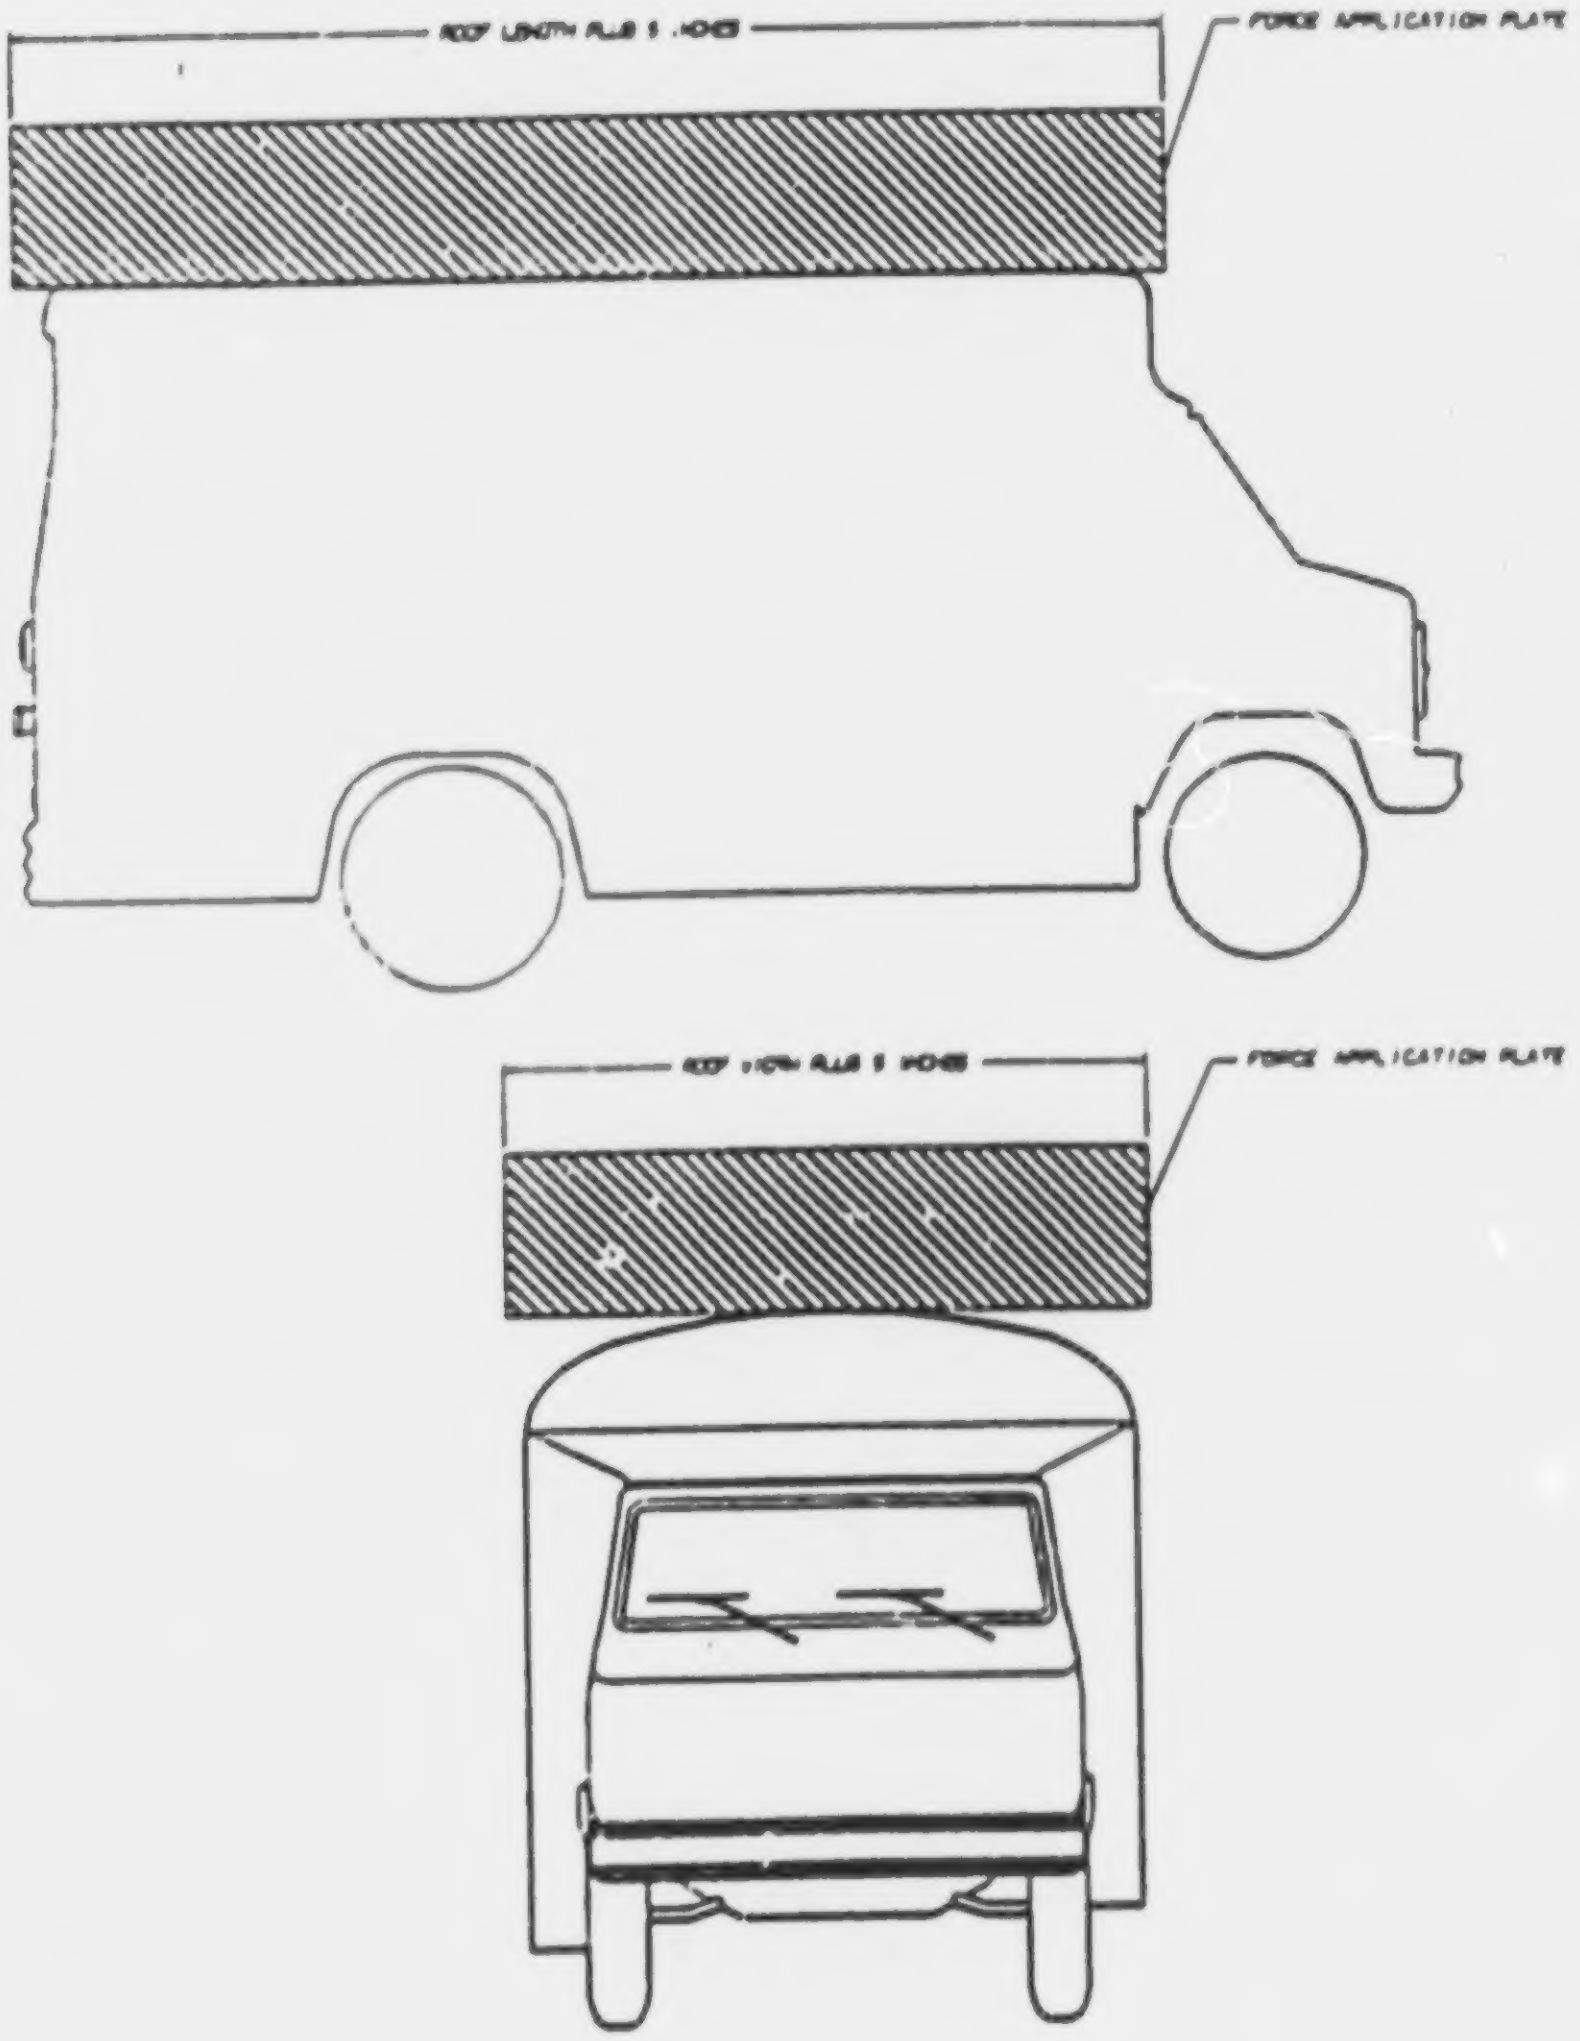
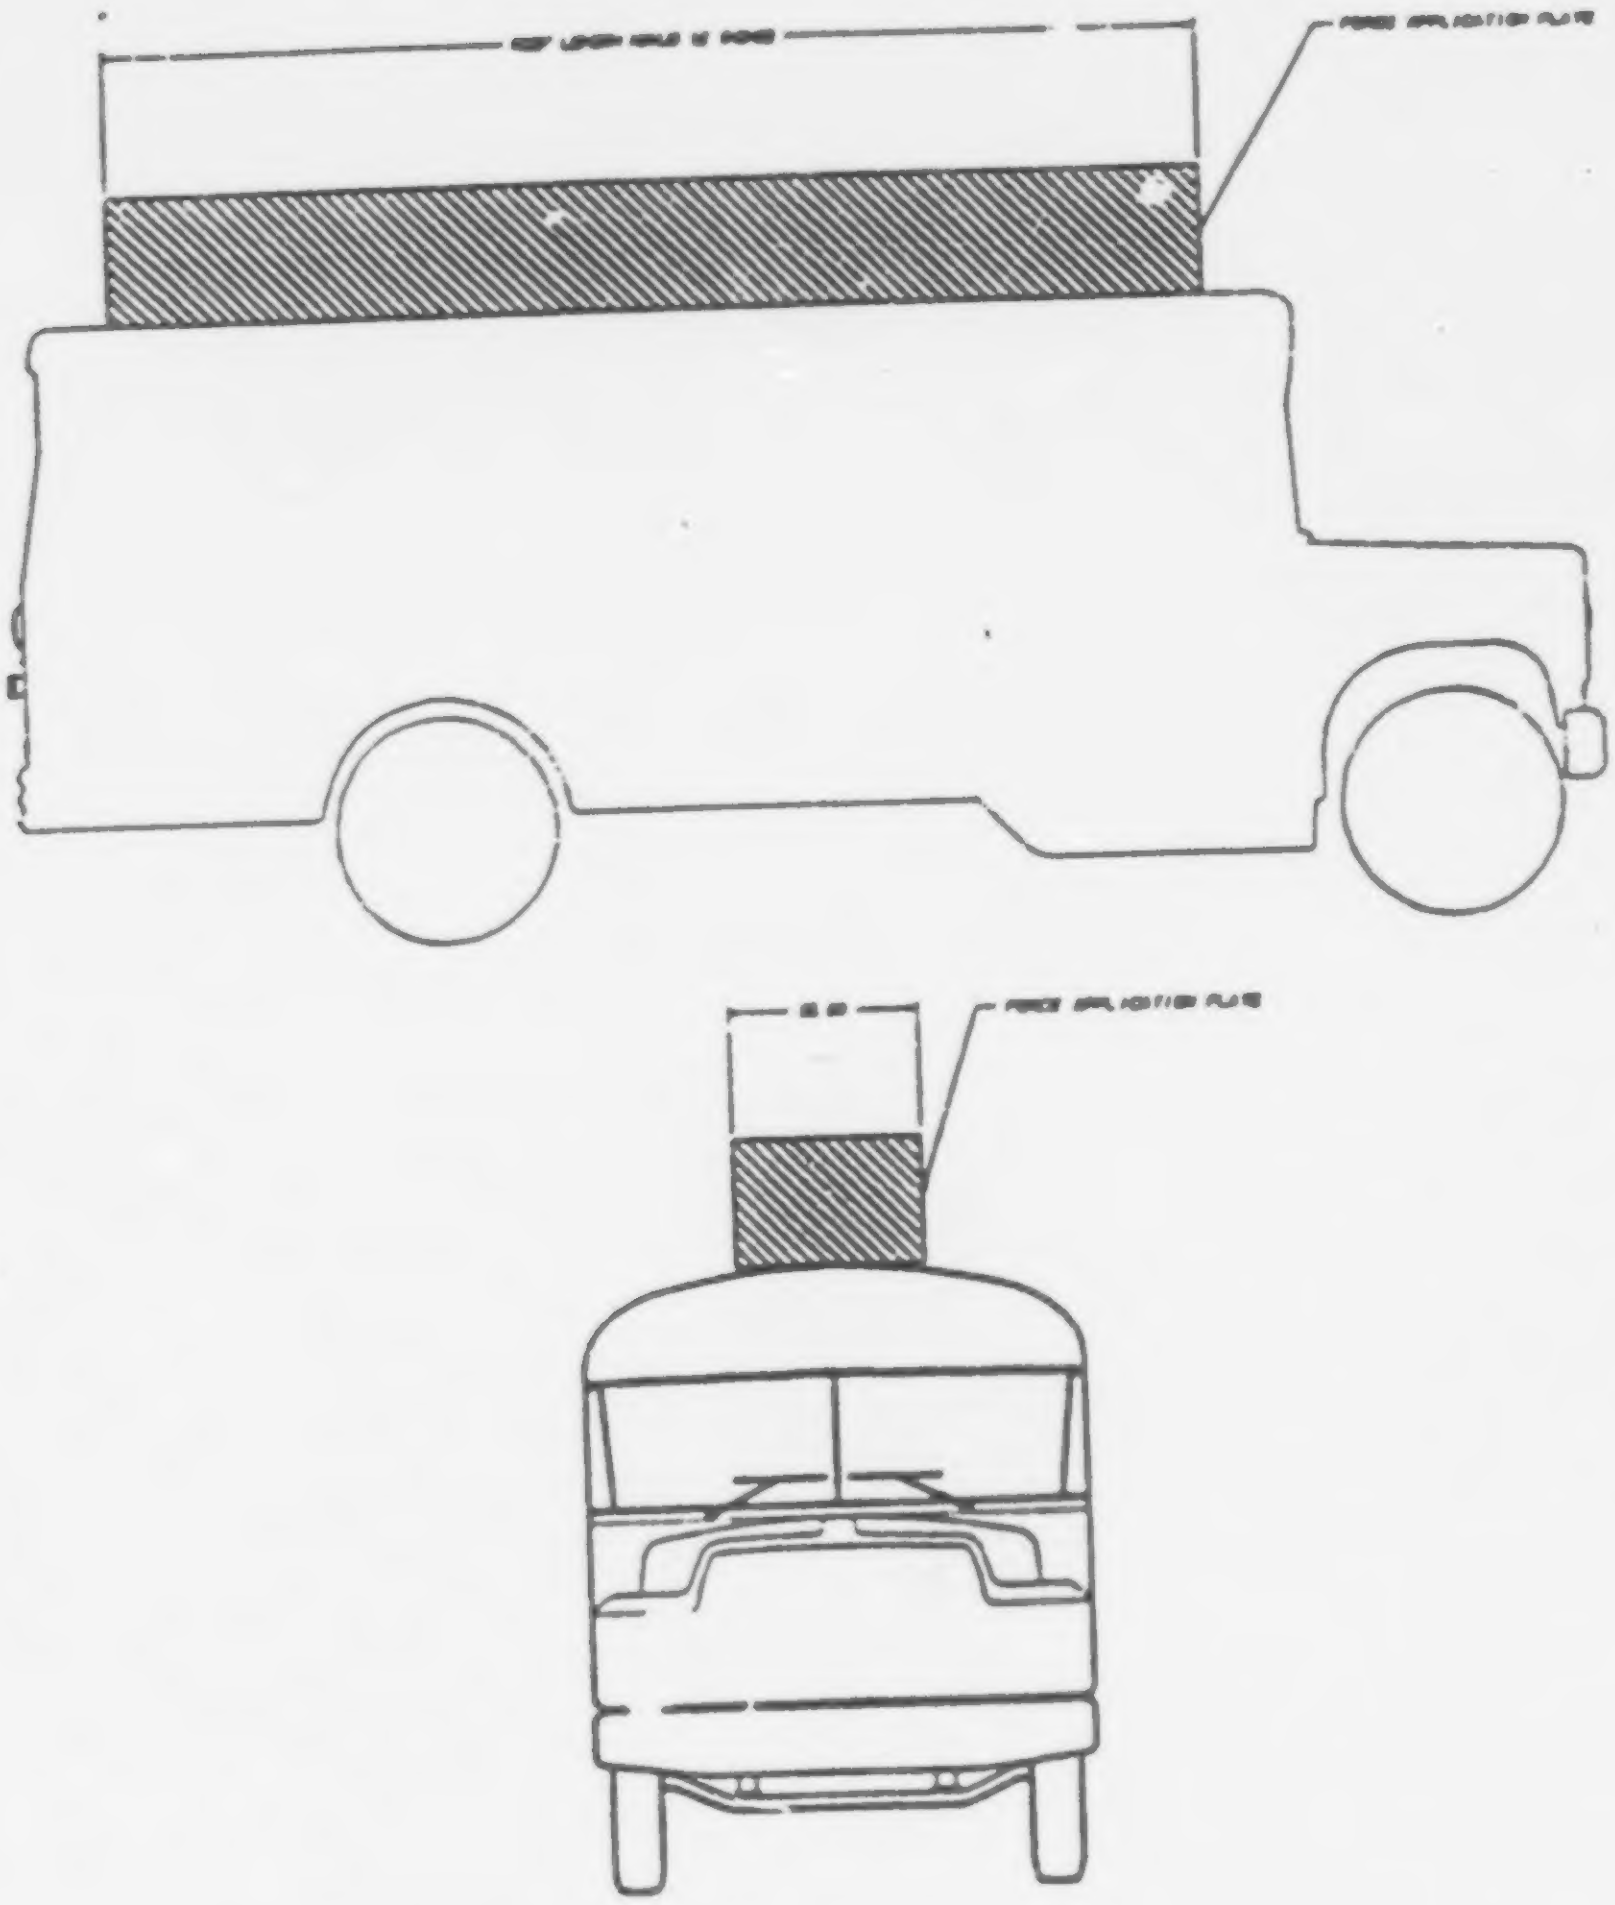
FMVSS 220
FORCE APPLICATION PLATE SIZE
SMALL SCHOOL BUSES

Figure 15.--A larger force application plate is used to test roof strength in small school buses compared to that used in tests of larger school buses. The result is that the roof of a small school bus must pass a less stressful test of roof rollover performance. (Source: School Bus Manufacturers Institute 1989.)

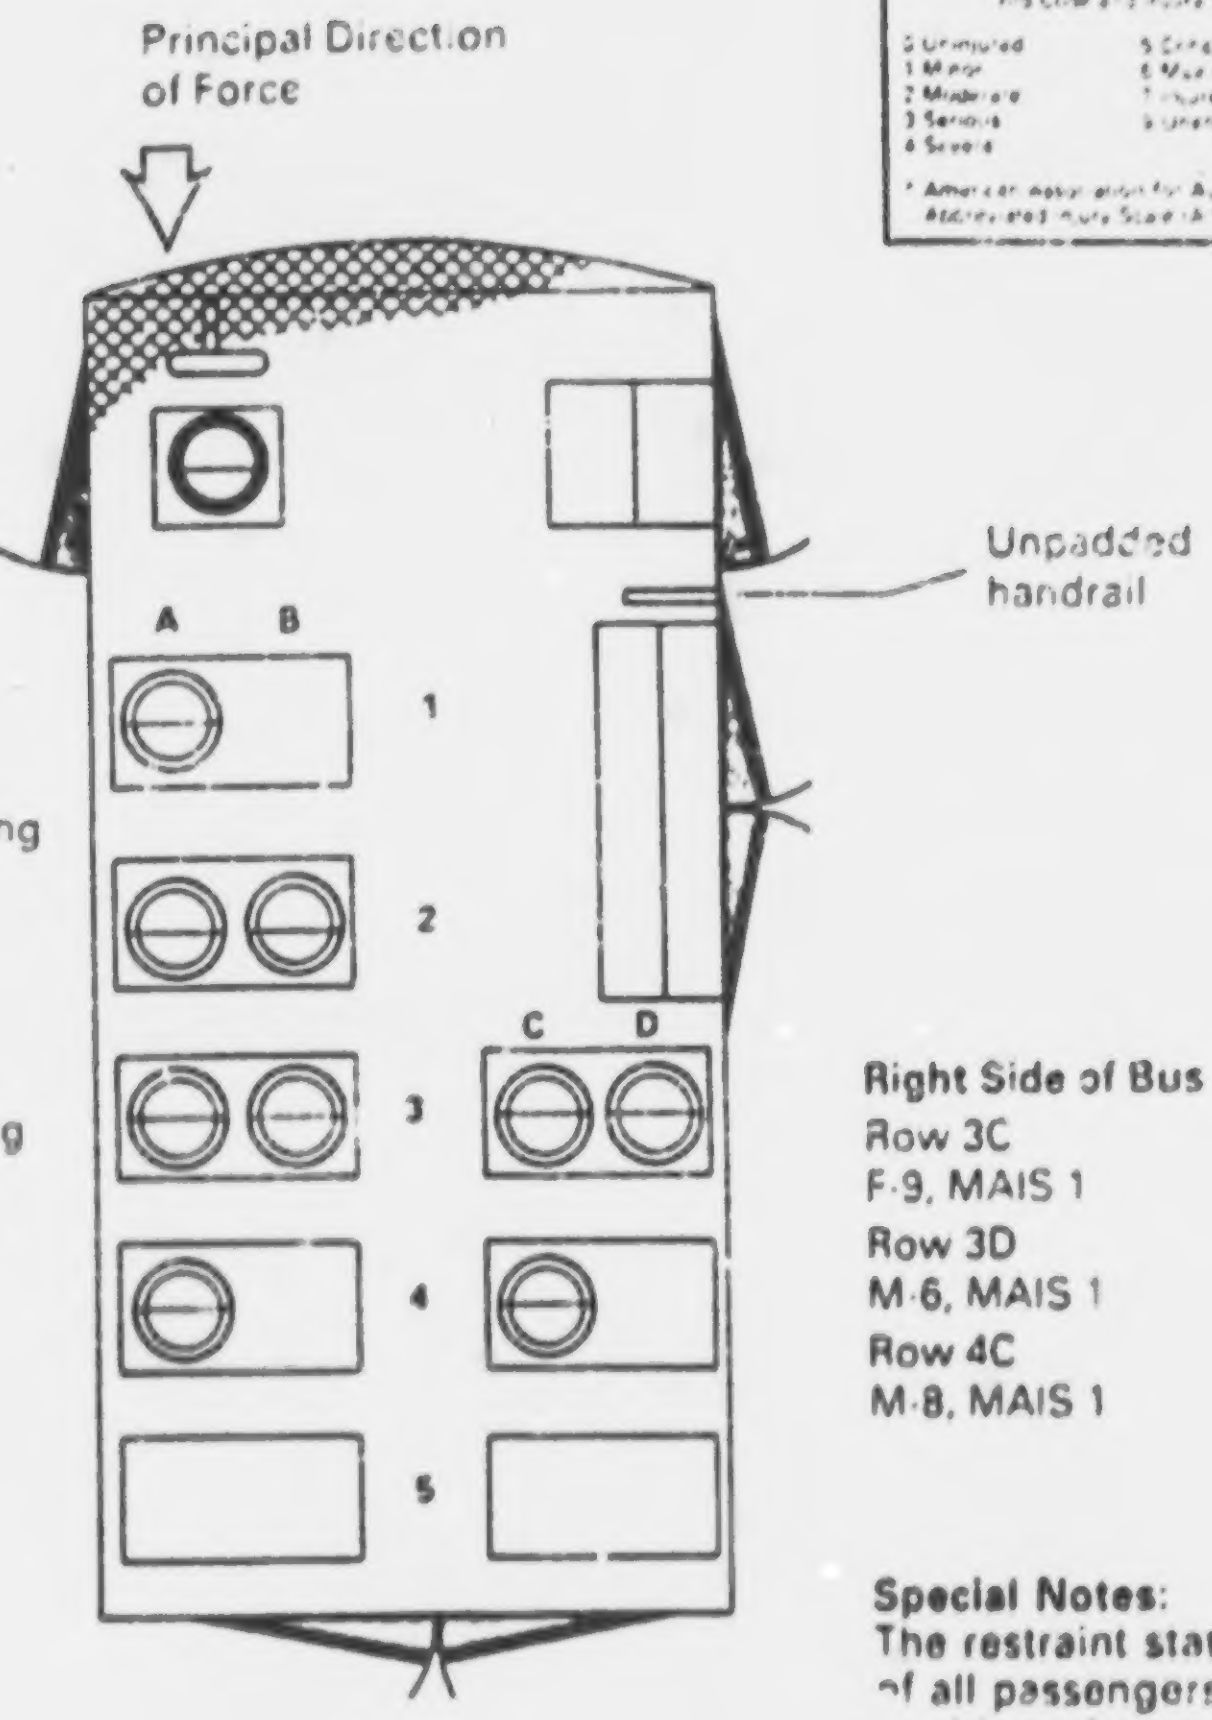
Pomona, California
Case Number 6

Left Side of Bus
Driver
M-72, MAIS 5
Lacerations of left lung
with hemothorax
Cardiac contusion
Flail chest
Fracture - sternum
Fracture - left femur
Contusion - right lung
Multiple abrasions
Multiple lacerations
Row 1A
F-12, MAIS 1
Row 2A
F-11, MAIS 1
Row 2B
F-8, MAIS 1
Row 3A
M-7, MAIS 1
Row 3B
M-13, MAIS 1
Row 4A
M-9, MAIS 1

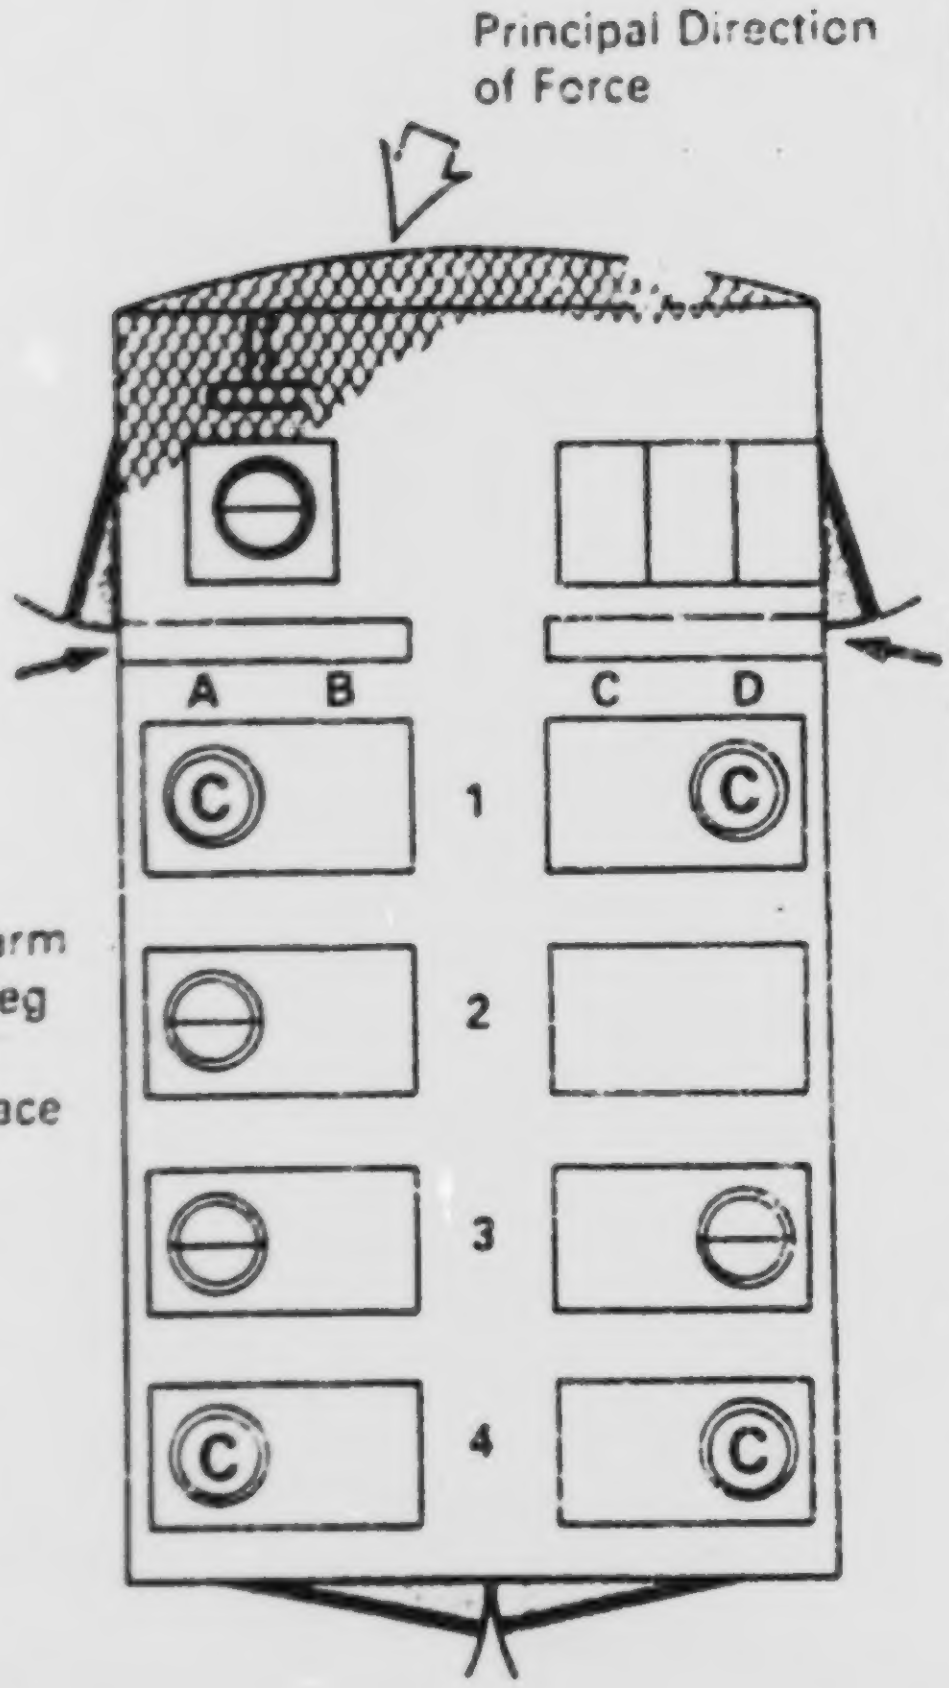
Allegan, Michigan
Case Number 7

Left Side of Bus
Driver
F-26, MAIS 3
Near amputation of left arm
Near amputation of left leg
Laceration on abdomen
Multiple lacerations on face
Laceration on right leg
Contusions on face

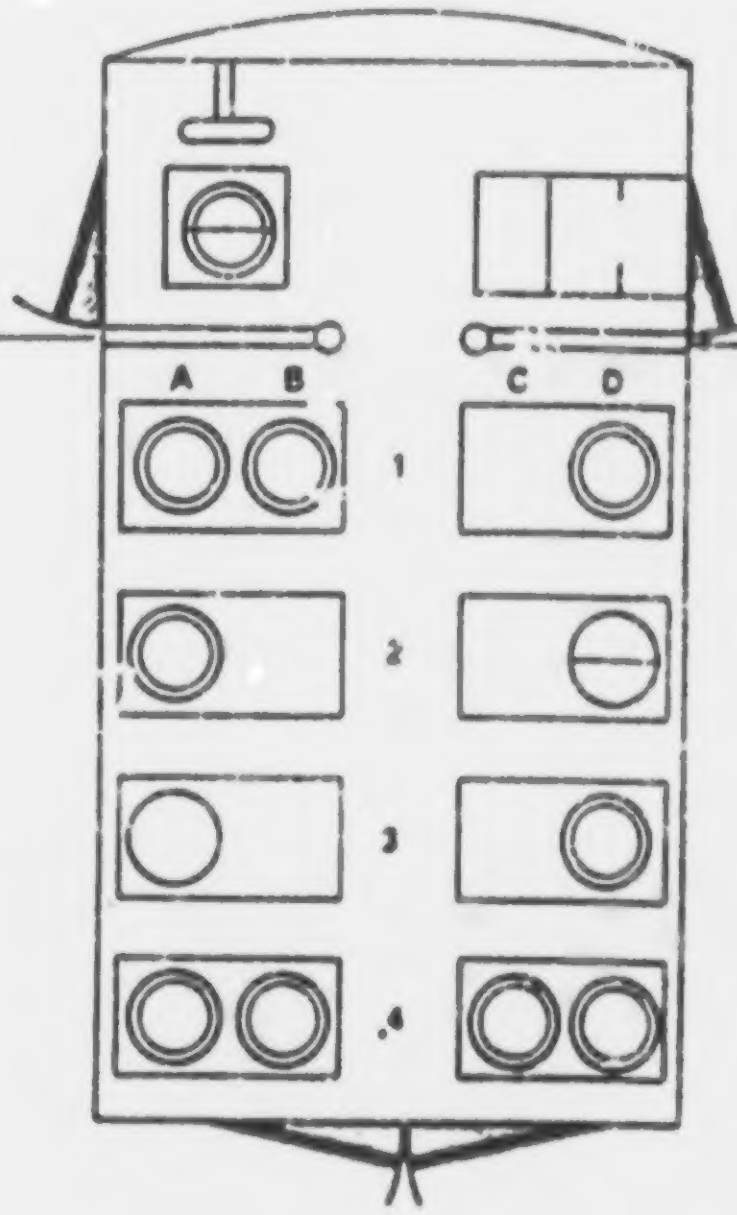
Nassau County, New York
Case Number 10

Left Side of Bus
Driver
F-38, MAIS 1
Row 1A
F-12, MAIS 1
Row 1B
F-11, MAIS 2
Fractured left clavicle
Contusion on left shoulder
Row 2A
F-9, MAIS 1
Row 3A
F-12, MAIS 0
Row 4A
M-11, MAIS 1
Row 4B
M-10, MAIS 1

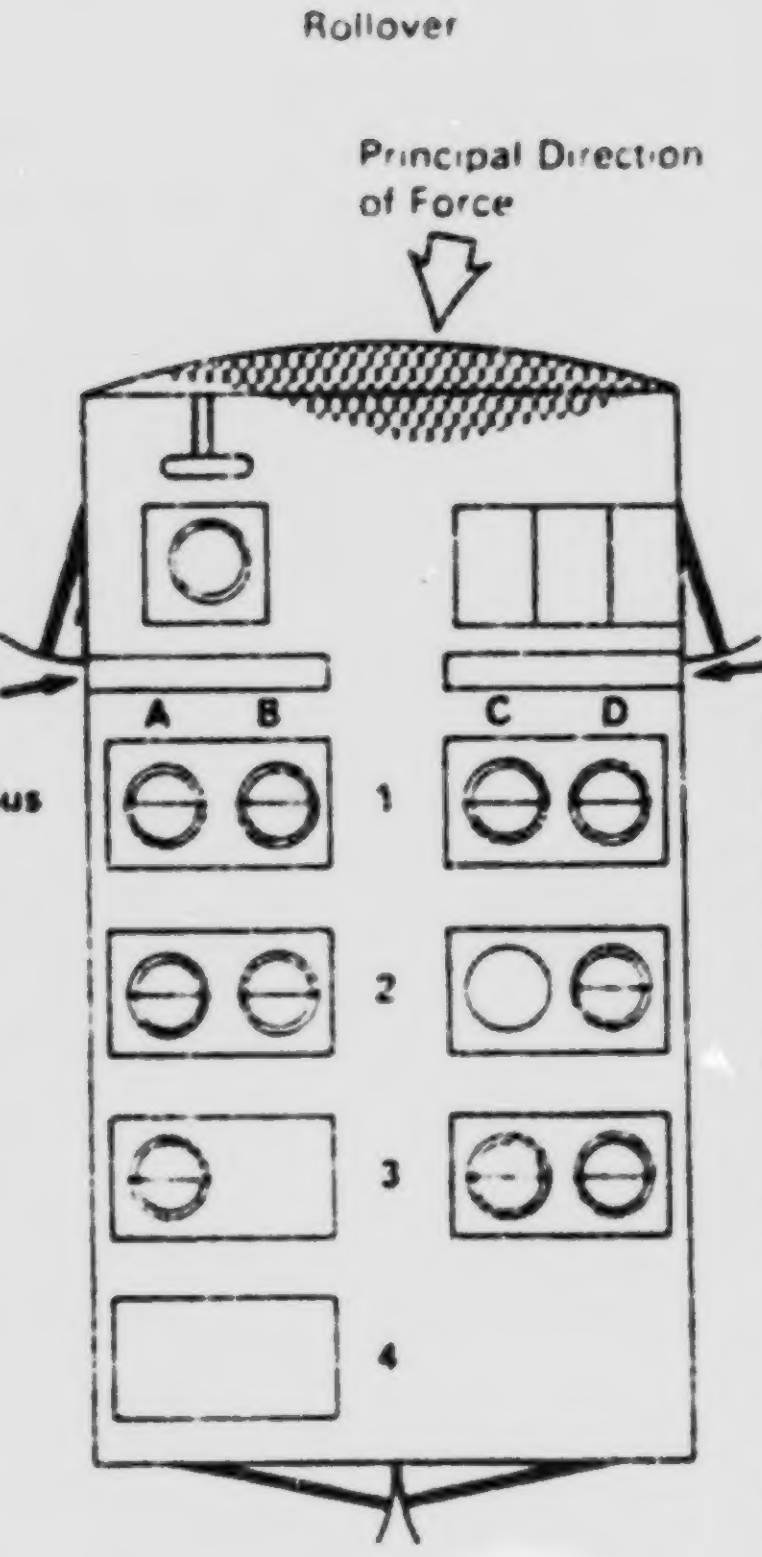
Gresham, Oregon
Case Number 12

The van body sustained exterior damage to the left front, extending 24 inches laterally with approximately 6 inches of rearward crush. The roof was collapsed inward and down 8 inches at the right front and 12 inches at the left front. Buckling of the roof and door frame above the passenger loading door rendered the door inoperative. The windshield was displaced from its frame during the rollover. The interior of the bus body sustained moderate crushing damage during the rollover and ground impact.

The panel above the rear emergency exit door was distorted, with five attachment screws displaced, but the door remained fully operational. The steering wheel was deformed forward and downward approximately 2 inches, and the driver's rearview mirror was shattered. A maintenance access panel, on the interior left side just to the rear of the driver's seat, was displaced about 2 inches, posing a potential hazard to passengers.

The poststandard van performed well in this moderate speed impact and full rollover. The only major structural failure occurred at the right front and resulted in the disablement of the passenger loading door.

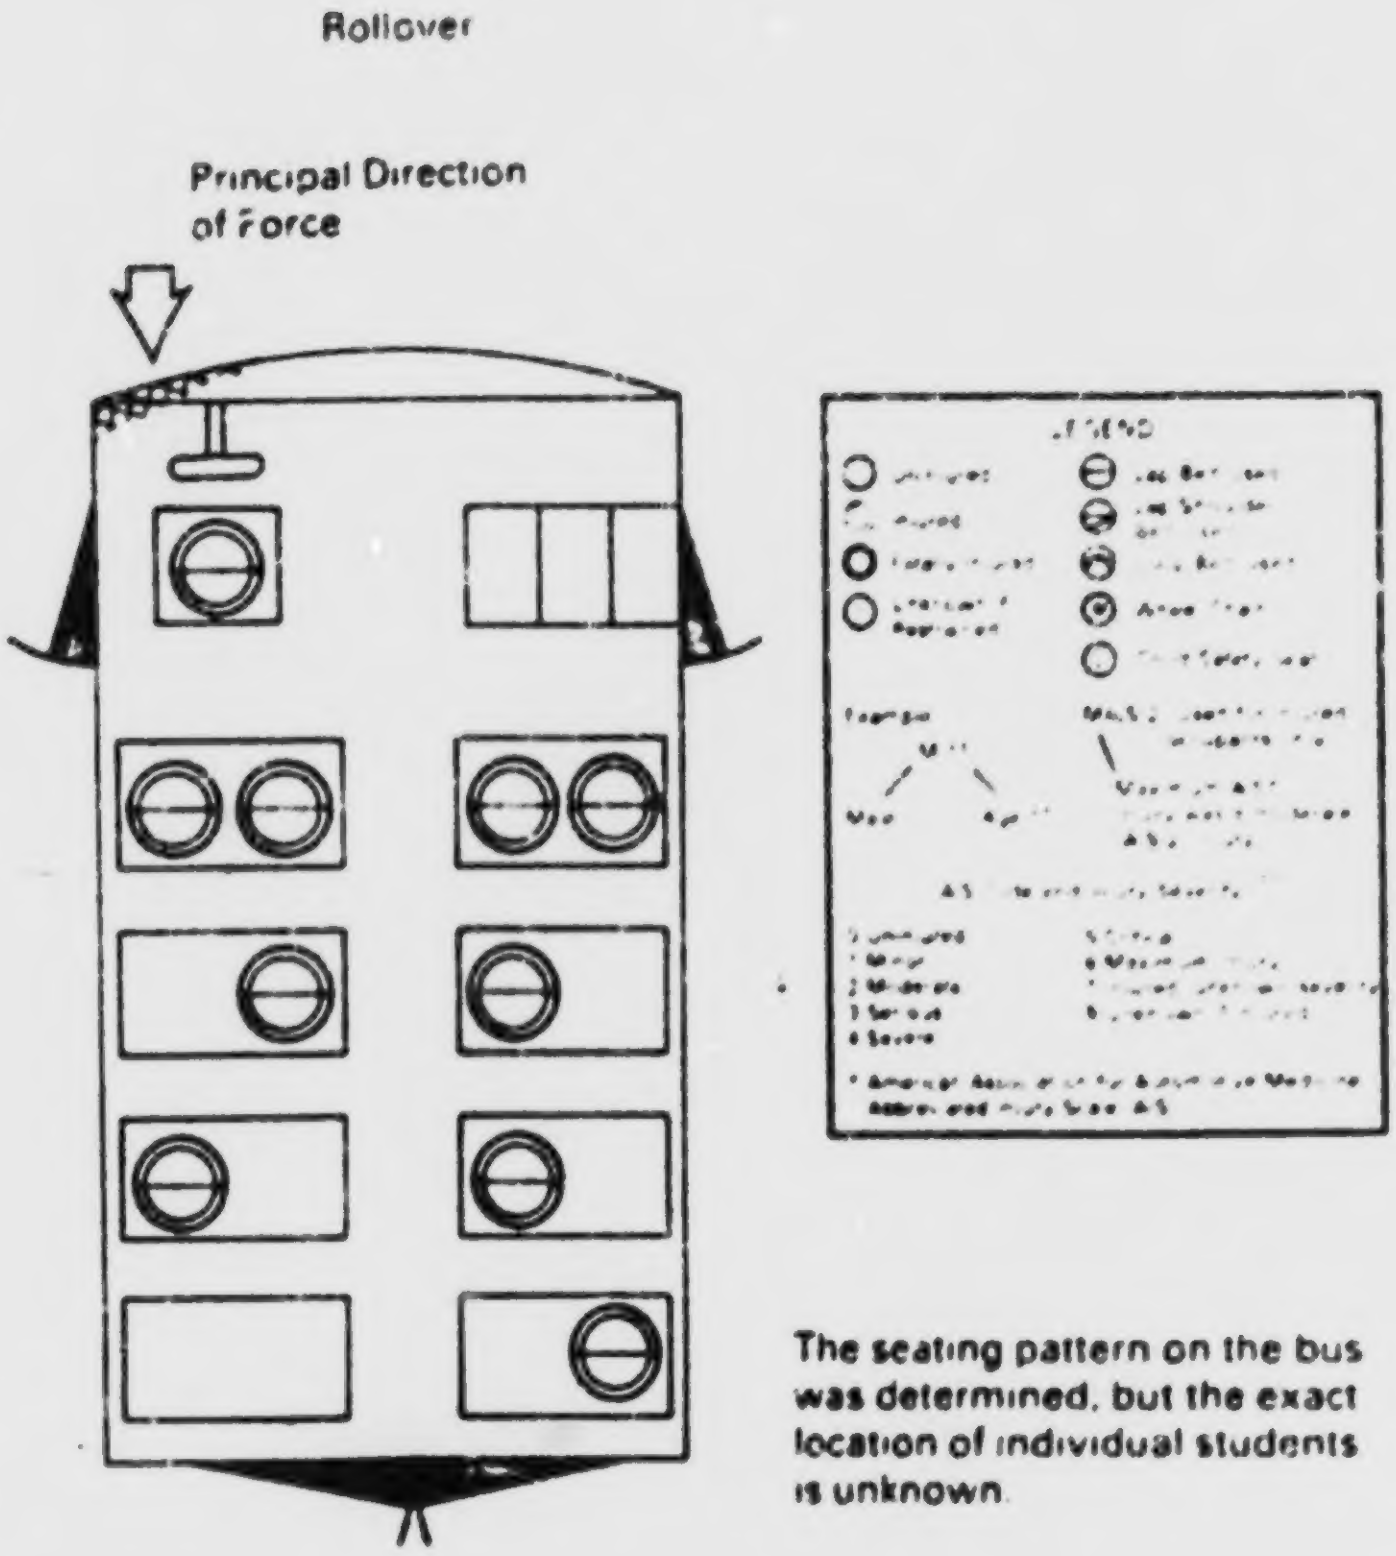
Houston, Texas
Case Number 13

All passengers were unrestrained. The passenger who was partially ejected out the second passenger window on the left side sustained a fractured pelvis (AIS 2). Had the passenger been wearing the available lapbelt, he would not have been ejected and possibly would have sustained a lesser injury; his specific injury, a fractured pelvis, could not have occurred. Had he been unrestrained but not ejected, he might have sustained injuries more comparable in severity to those sustained by other passengers: six were uninjured and four sustained only minor (AIS 1) injuries.

The driver was wearing the available lap/shoulder belt and sustained only minor (AIS 1) injuries. Had the driver not been restrained, she could have sustained more serious injuries from being propelled into the sheet metal of the collapsing roof.

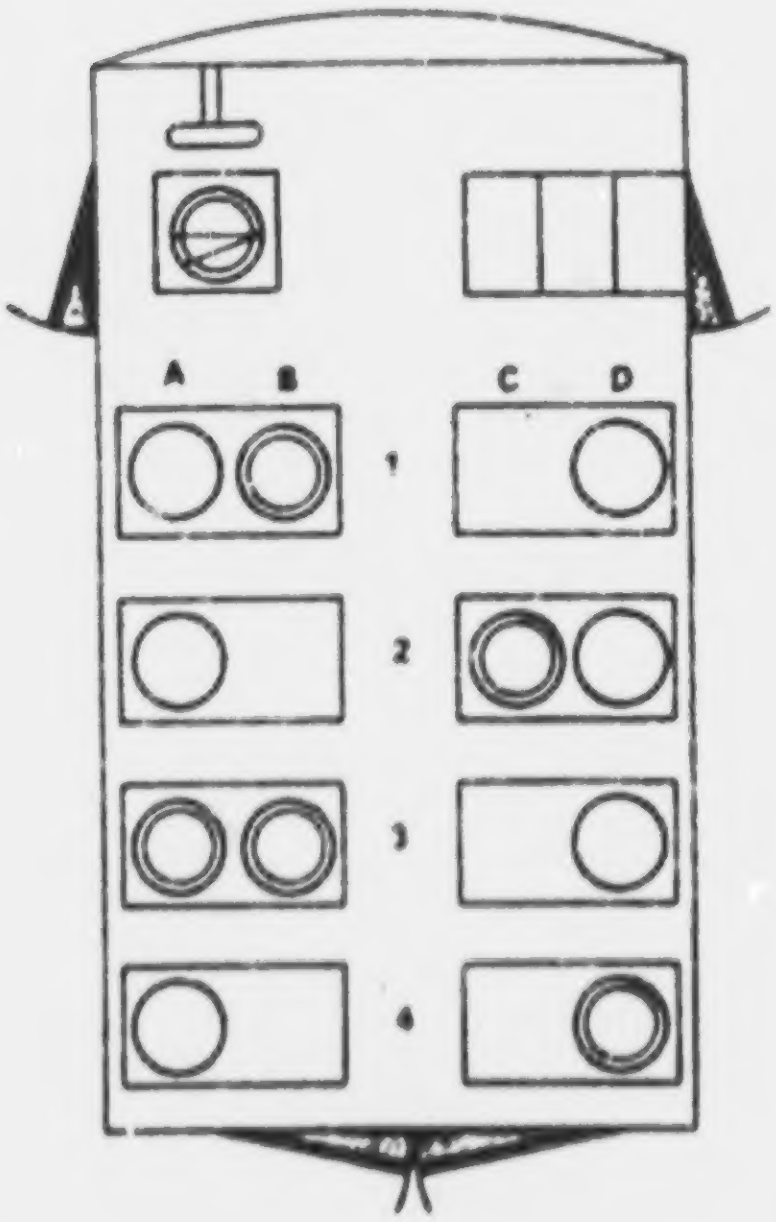
Weschester, New York
Case Number 14

Left Side of Bus
Driver
F-35, MAIS 1
Row 1A
M-14, MAIS 0
Row 1B
M-15, MAIS 2
Fractured pelvis
Abrasion on left knee
Row 2A
M-16, MAIS 0
Row 3A
M-15, MAIS 1
Row 3B
M-17, MAIS 1
Row 4A
M-17, MAIS 0
